**DEPARTMENT OF TRANSPORTATION**

Contract #: 04-0120F4Cty: SF/ALA Rte: 80 PM: 13.2/13.9File #: 69.28**WELDING INSPECTION REPORT****Resident Engineer:** Pursell, Gary**Address:** 333 Burma Road**City:** Oakland, CA 94607**Report No:** WIR-007526**Date Inspected:** 15-Jun-2009**Project Name:** SAS Superstructure**OSM Arrival Time:** 700**Prime Contractor:** American Bridge/Fluor Enterprises, a JV**OSM Departure Time:** 1900**Contractor:** Zhenhua Port Machinery Company, Ltd (ZPMC), Changxing Island **Location:** Shanghai, China**CWI Name:** Xu Le Feng, Liu Yang**CWI Present:** Yes No**Inspected CWI report:** Yes No N/A**Rod Oven in Use:** Yes No N/A**Electrode to specification:** Yes No N/A**Weld Procedures Followed:** Yes No N/A**Qualified Welders:** Yes No N/A**Verified Joint Fit-up:** Yes No N/A**Approved Drawings:** Yes No N/A**Approved WPS:** Yes No N/A**Delayed / Cancelled:** Yes No N/A**Bridge No:** 34-0006**Component:** TOWER**Summary of Items Observed:**

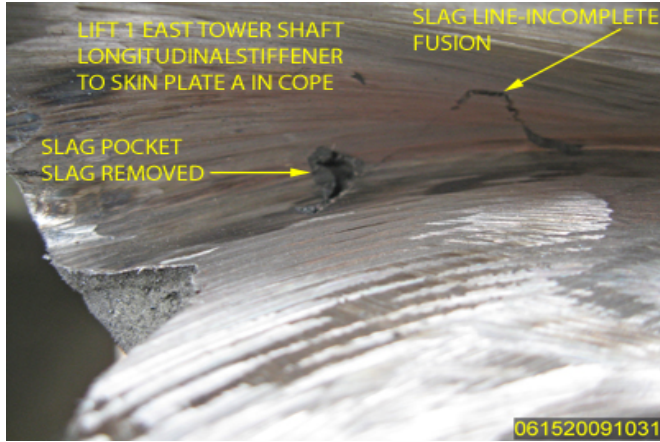
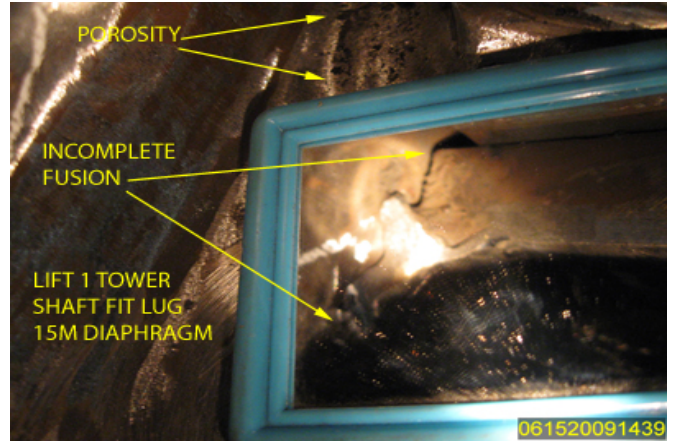
The QA Inspector randomly observed that the welds in the copes attaching the 2 longitudinal stiffeners Skin Plate A on Lift 1 East, had been ground to try to remove porosity, slag and incomplete fusion observed during a previous random visual inspection. The QA Inspector randomly observed that the indications still remain. The attached photograph provides additional detail.
